PASTON HALL - A NEW APPRAISAL

James Mindham

A CONTEXT FOR RECONSTRUCTION

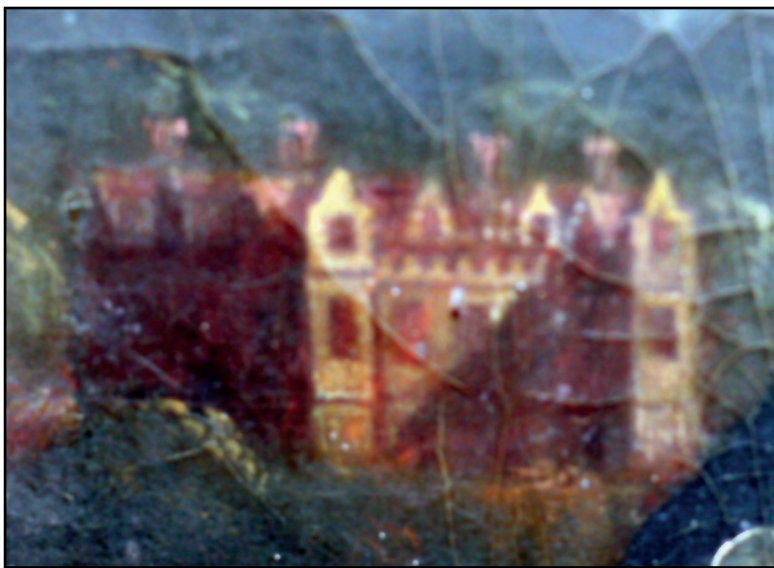
Fig.1 'the great rose-coloured mansion'

One of the most revealing of sources is the 'great rose-coloured mansion' that appears in a portrait of Sir William Paston (1528–1610). Whether this portrayal of Paston Hall is merely a token building or something that is actually representative of the Hall remains unclear. Personally I believe it shouldn't be dismissed altogether.

The crenellations over what seems to be the porch, shouldn't be there as no evidence has been found to date of a license to embattle, and the house seems a little too isolated unless this is a portrayal of the mansion that William Paston built in insolation from the other ranges that would have existed.

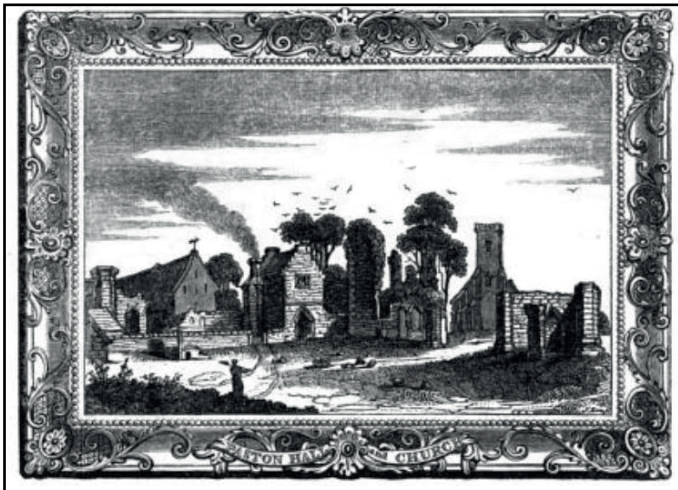
Fig.2 The print that Tilney-Spurdens refers to

By far the most helpful source we have in terms of describing the Hall complex, is the testimony of the **Reverend John Tilney-Spurdens** with his thoughts on the print which appears as a plate within the Fenn Papers vol 5 (fig.2). This print was based on based on Josiah Boydell's 1790 watercolour.

north and south sides of a courtyard, and we could interpret this as a series of buildings or rooms making up the service wings, within which, the day to day running of the mansion was carried out. He said that the mansion itself occupied the east of the courtyard (with the hall to the left and the kitchen on the right) and a large turreted gateway to the west.

Tilney-Spurdens said that the print was 'very inadequate' in terms of conveying an idea of the ruins when he visited them around the year 1796, six years after Boydell painted them. He describes a layout which would fit the typical plan of a Tudor Mansion (fig.3) or College and Anthony Norris (1711 - 1786) who compiled detailed, but unpublished, histories of the eastern hundreds of Norfolk, said that the hall,

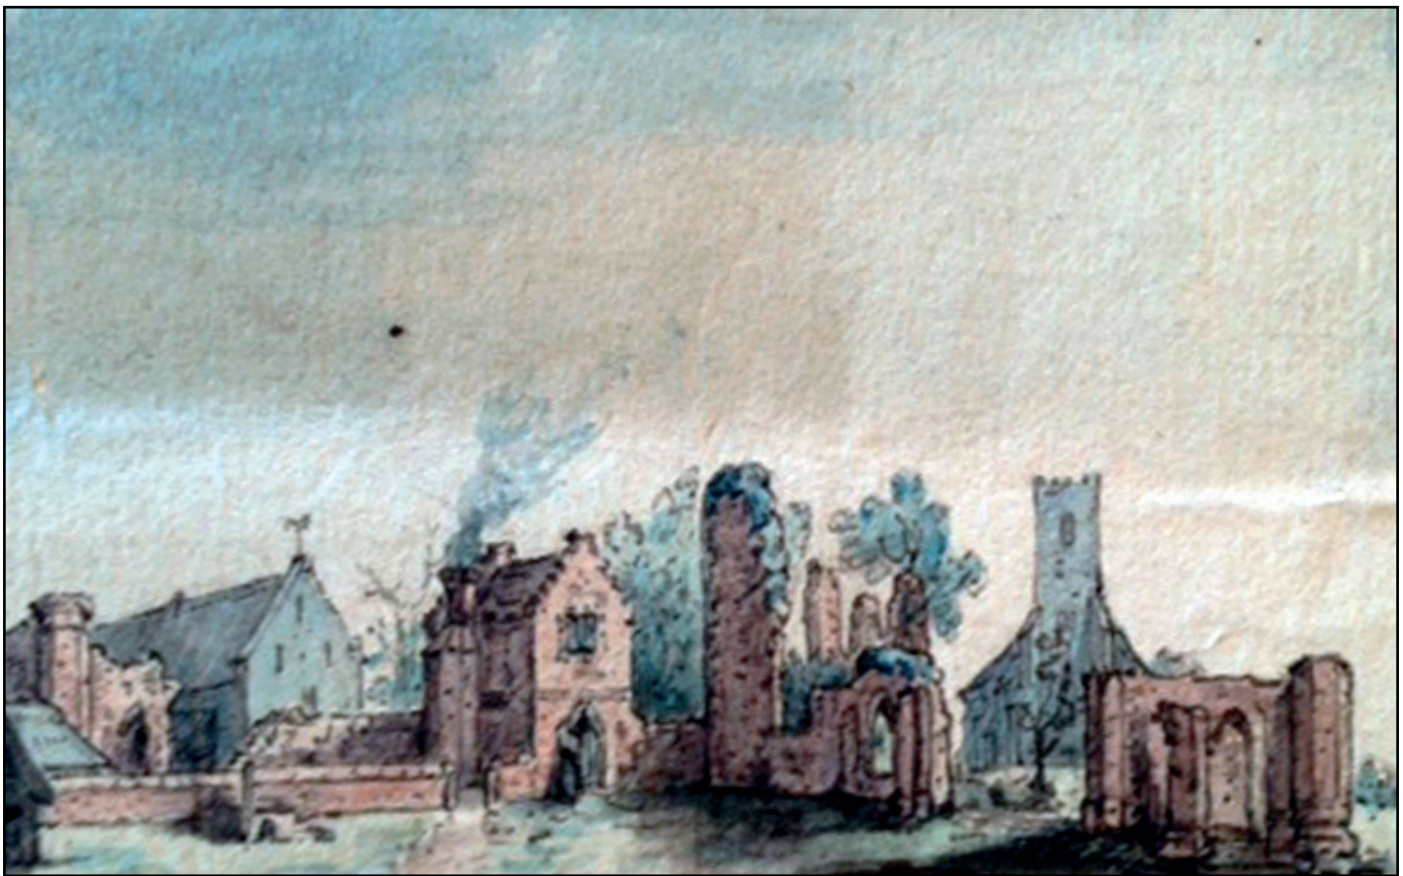
Fig.4 Josiah Boydell's watercolour sketch dated 1790

His watercolour sketch (Fig.4) presents us with a confusing picture. Although we can only see parts of the north and east sides of the complex, and it seems that there is very little we can pin down in terms of the previous descriptions of the ruins. I believe we need to think of in terms of where the scene was painted and what is missing.

In short, I believe Boydell is positioned in the south western corner of the courtyard. The Barn and Church enables us to get a quick location fix, but I also believe that the well within the 'inner court' that Blomefield refers to below, is the structure just in front of the low wall.

In terms of the 'inner court', it is possible that Blomefield is interpreting the northern range as a separate court defined by the low wall in Boydell's picture. We cannot be sure that this wall is in fact anything to do with the original complex and may be a later addition for agricultural purposes as it doesn't seem ruinous enough.

However, we cannot discount the idea that the northern range was essentially another courtyard containing service buildings. Indeed, the building with the chimney (used as a blacksmith's shop at the time of the painting) does look as though it had always been a 'standalone' building and not part of a wing, and it seems to bear a scar where a perhaps a tall enclosing wall may butted against it.

Clearly the large flint gateway to the west is missing because it’s to the left of the scene and ‘out of shot’. Yet we should have a clear view of the eastern range which contained the mansion. We can see ruins of a building or buildings that are maybe three stories high and we can be fairly sure that these have something to do with the mansion. But where is the Great Hall and kitchen, that both Blomefield and Spurdens recall?

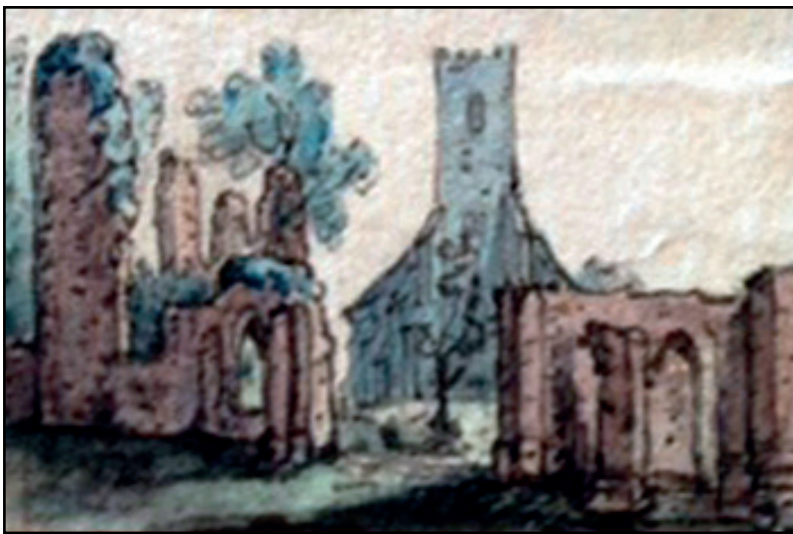
Fig.5

It is not entirely clear what he is referring to; ‘the centre of the front’ of what? But I believe he is talking about the Mansion, specifically what we see in the middle right of the Boydell watercolour (Fig.5).

There seems to be an entrance (the gap with the church visible) flanked by two small turrets. This gap is certainly in the ‘centre of the front’ of this ruin and there even seems to be the suggestion of steps leading up to an entrance. Blomefield made reference to a staircase out of the hall;

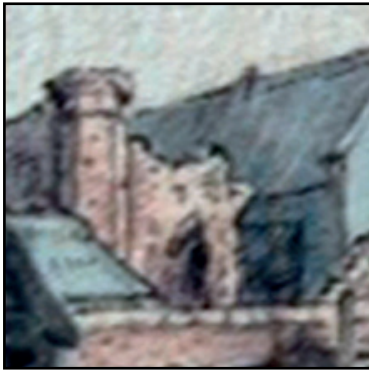
Fig.6

What about the ‘turreted gateway’ (fig.6) seen at the back of the picture? Could this be another case of artistic license by Boydell? Tilney-Spurdens only mentions one turreted gateway;

So what is the ruinous building in fig.6? To me it does not seem to sit comfortably in the scene. When trying to reconcile the Boydell ruins in 3D, this building appeared to be beyond the limits of the Hall and far too close to the barn.

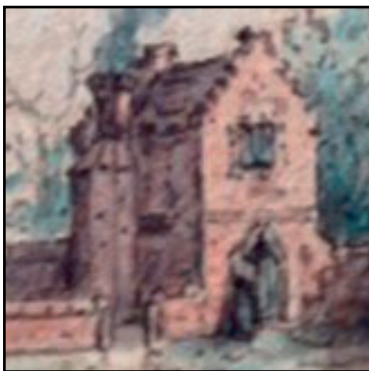
Fig.7

The ‘Account of the Plates’ from the Fenn Papers Volume 5 states that the gateway seen in the print was used as a blacksmith’s shop, and I believe that it was referring to the building with the chimney (fig.7). It seems much more likely that a blacksmith would use an intact building rather than a ruin.

We also know that Tilney-Spurdens referred to the building with the chimney as ‘*the arched gate*’ and that it was “*a passage from the court to the farm buildings*”.

As it was destroyed down to the string course and used as a pig sty during his visit, we can safely assume that it was no longer used as a blacksmith’s shop by 1796.

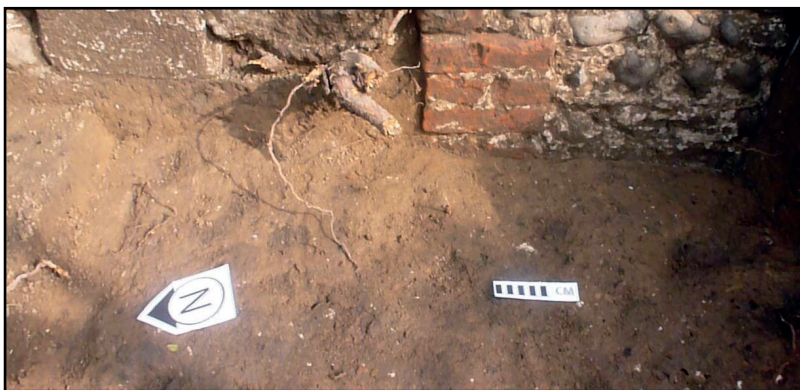
In April 2013, a small exploratory trench was opened against the kitchen garden wall in order to try and establish a possible date for the older part of the wall. The construction trenches for both walls cut into a layer containing 16th century stoneware. The older phase contained re-used stone to form a foundation for the flint and brick wall, it was suggested by Stephen Heyward that this stone would have come from Bromholme Priory.

fig.10 The older wall to the left containing re-used stone from Bromholme

The later phase which clearly butts up against the older wall, may have been built around the same time that the ruins were finally pulled down and the new house built. The wall can be seen on the 1812 Enclosure Map, which suggests that this was the case, rather than John Mack building it after he acquired the estate in 1824.

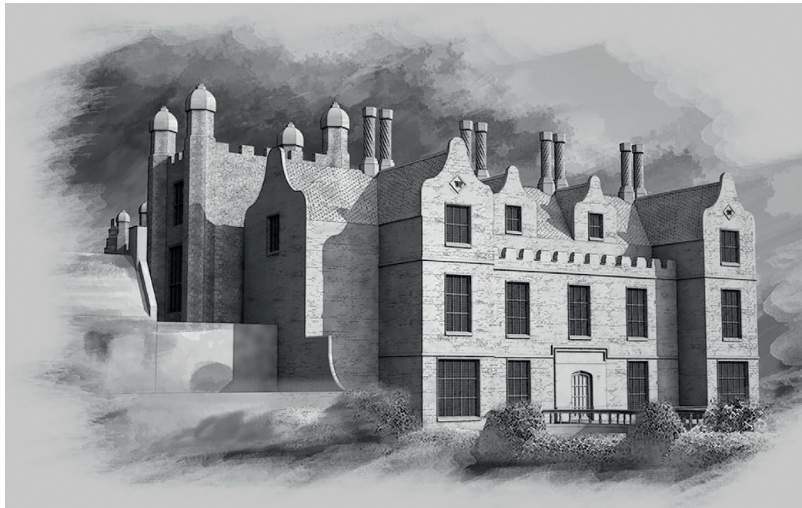
Fig.17 The southern wing

The impression (Fig.17) of the hall is based on the GPR results and inspiration from the Hall seen in the William Paston portrait (right). Its quite possible that the building seen in the portrait is only the southern wing.
